1 **Case Study: Monitoring and Analysis of two road stretches applying**
2 **Pavement Rehabilitation Solutions in State of Ceará/Brazil**

3 Carlos Roberto Cunha¹, Raul Serafim Ponte², Filipe Braid Carannante³, Adriano Sampaio Lima⁴,
4 José Sérgio Fontenele de Azevedo⁵, João Bosco de Castro⁶

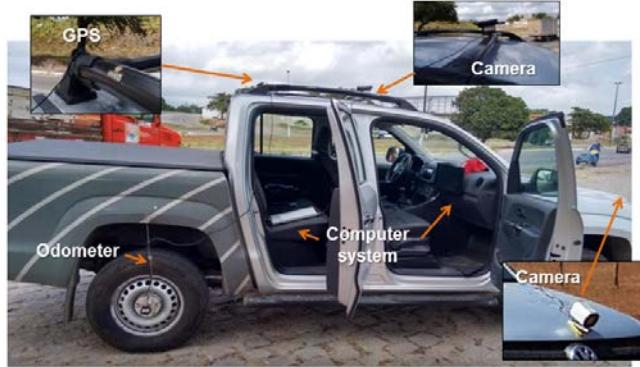
5 **FIGURE 1 Vehicle used in field surveys**

41 Among the monitoring actions and field studies carried out by DER/CE, Pavement
42 Surface Defect Surveys (Continuous Visual Survey – CVS) and the measurement of the
43 International Roughness Index (IRI) of the pavement surface were used as analysis tools. The
44 Pavement Surface Defect Survey is made with an automated apparatus. A digital odometer, GPS,
45 two high-definition cameras (one on the top of the vehicle, for a panoramic register, and the

1 other on the hood, aiming at the pavement, for defects registration) and a computer with a defect
2 registration system are attached to the vehicle, as seen on Figure 1. The IRI measurement is done
3 with the same equipment set, adding the Laser Surface Profilometer.

11 The IRI measurement, a way to evaluate the pavement smoothness (ride quality) was
12 done with a Laser Surface Profilometer (Class II Equipment). This equipment has a road
13 pavement longitudinal profiling system, which is aided by distance sensors (lasers),
14 accelerometers, odometer, and speedometer, and it collects inputs for the IRI calculation by a
15 microprocessed system [7]. IRI values were calculated for every 200m of the segments. In this
16 work, the weighted average of the values is presented.

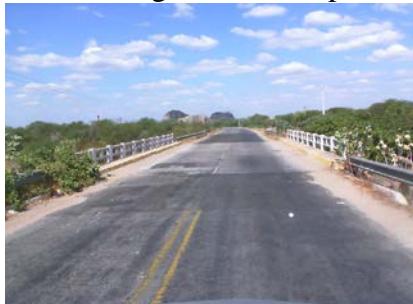
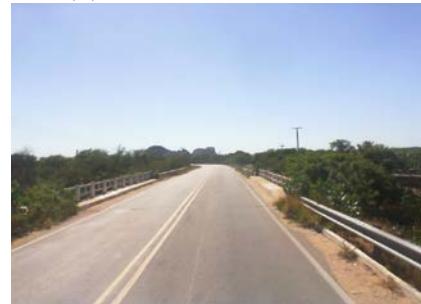
FIGURE 2 Pictures before and after the pavement rehabilitation in Stretch 1

3 The segment's original surfacing was a Double Surface Treatment (DST) and has already
4 shown surface wearing, fatigue cracking and patching. At that time, maintenance actions were
5 solicited more frequently and their costs were increasing.

6 After a previous evaluation, functional and structural surveys, and a field inspection, the
7 pavement rehabilitation solution designed was a full-depth reclamation (blending the full
8 thickness of the surface with the base) with a Double Surface Treatment re-surfacing in places
9 where a more severe intervention was needed (on approximately 20% of the stretch), and the
10 application of 2-layers cold microsurfacing (on the remaining 80% of the extension of the
11 segment). The road works were carried out between July and November of 2013, with an
12 average cost of R\$ 94,501.95 (US\$ 41,857.62) per km, in terms of costs at the time of the
13 intervention [9]. Figure 2 shows pictures before (a) and after (b) the road works.

(a) before – 09/2012

(b) after – 10/2016

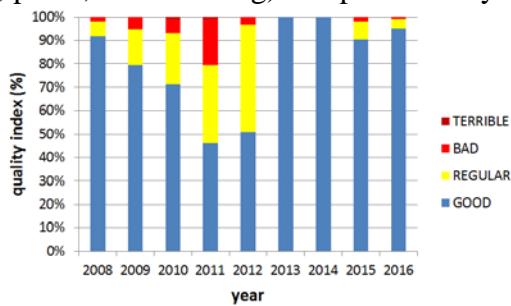
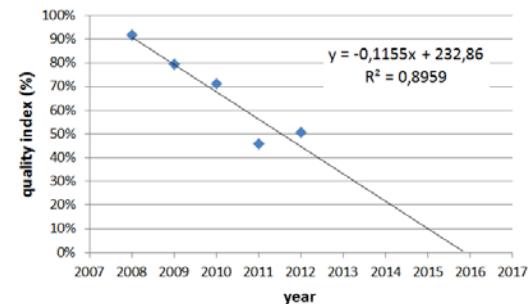
FIGURE 3 Pavement quality analysis prior to and after the pavement rehabilitation in Stretch 1

14 Figure 3(a) shows the evolution graph of the pavement surface quality, classified in 4
15 groups: good, regular, bad and terrible. The data shown on this graph is a quality index
16 calculated by SIGMA for each segment of state road mesh, based on distresses registered on
17 CVS surveys. In the graph, it is possible to observe that even after 4 years of the pavement
18 rehabilitation, 95% of its extension can be classified as being in good condition. A trend line
19 with the data prior intervention ($R^2 = 90\%$) was traced, as seen in Figure 3(b). It is possible to
20 notice that, without any action, the segment would be completely collapsed by 2016. Due to the
21 small variation in the quality index, the trend line obtained after the intervention is not accurate
22 (R^2 was lower than 50%). The variance on the results shown in the graph is explained by its
23 dependence on other factors such as the amount of investment on minor maintenance actions

24 (e.g., patch, crack sealing) and pluviometry.
25

(a) Evolution of the pavement quality

(b) Prior intervention trend line

Prior to the pavement rehabilitation, the IRI values were rising, from 2.465mm/m in 2008, to 2.788mm/m in 2012 (measurement made before the intervention). In 2016, measured IRI was 2.714mm/m. According to DNIT (2013)[10], which defines limits for IRI values as: good ($IRI < 3\text{mm}/\text{m}$), regular ($3\text{mm}/\text{m} \leqslant IRI < 4.5\text{mm}/\text{m}$), and bad ($IRI \geqslant 4.5\text{mm}/\text{m}$), the stretch was classified as good, even after 3 years of pavement rehabilitation works.

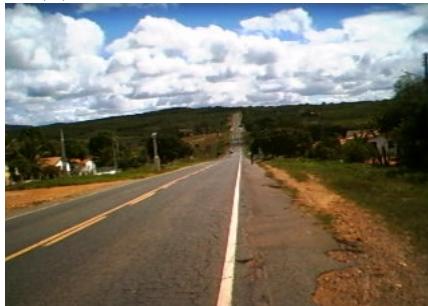
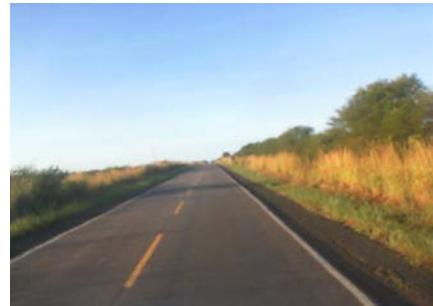
FIGURE 4 Pictures before and after the pavement rehabilitation in Stretch 2

The ADT of the segment in 2012 was 5,788 vehicles daily, 11.3% of them being heavy-vehicles (buses and trucks). The expected annual growth rate was 6.74% [8]. The segment original surfacing was Asphalt Concrete (AC), and the most common distress was fatigue cracking. Rutting or other deformations were not observed. Figure 4 shows pictures before (a) and after (b) the road works.

(a) before – 09/2010

(b) after – 10/2016

The duplication of this segment was scheduled to happen in 2017. The main goal of Pavement Rehabilitation on this case was to keep the stretch in good conditions until the execution of the road works. The proposed solution was resurfacing the whole extension with AC with a thickness of 3cm and full-depth reclamation or milling, in the more degraded segments at an average cost of R\$ 139,427.46 (US\$ 89,376.58) per km, in terms of costs at the time of the intervention. It is worth to mention that if a wider intervention on the highway were not scheduled in a mid-term, crack control measures, such as Stress Absorbing Membrane Interlayers (SAMI), constructed under asphalt overlays should be designed, in order to achieve a longer lifespan of the rehabilitated pavement [2].

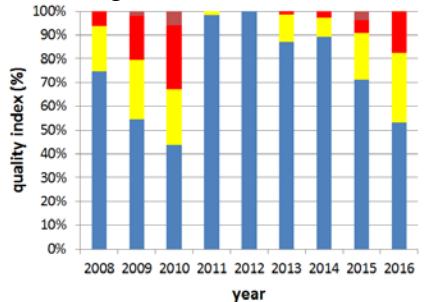
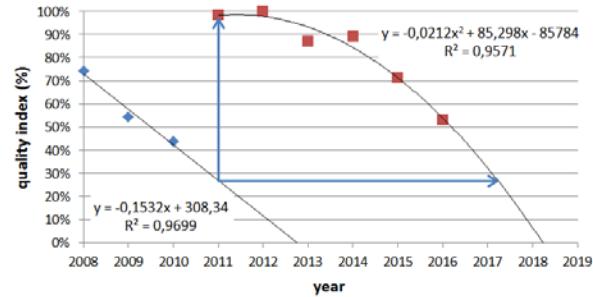
FIGURE 5 Pavement quality analysis prior to and after the pavement rehabilitation in Stretch 2

Monitoring of this stretch shows that the objective was accomplished. The Pavement Surface Quality evolution graph (Figure 5 (a)) shows that the percentage of the highway

extension considered good went from 44% to 98%, and it was expected to return to its previous stage by the middle of 2017. If no measures were taken, the segment would be collapsed by 2013 (Figure 5 (b)). The duplication road works in an extension of 22km within this segment, connecting Missão Velha to Barbalha, began in February 2017.

(a) Evolution of the pavement quality

(b) Prior to and after intervention trend line

On this stretch, pavement rehabilitation had a considerable impact on IRI, making its classification go from regular in 2008 (3.295mm/m) to good (2.511 mm/m) in 2011. On the last measurement made after the intervention, in 2016, the measured value was 3.021mm/m. The results obtained from the economic evaluation of the pavement rehabilitation on this segment indicates that the investment made on this stretch had an IRR of 15.2% .
